Restoring discoloured uncoated timber cladding

Peter Kaczmar

Introduction

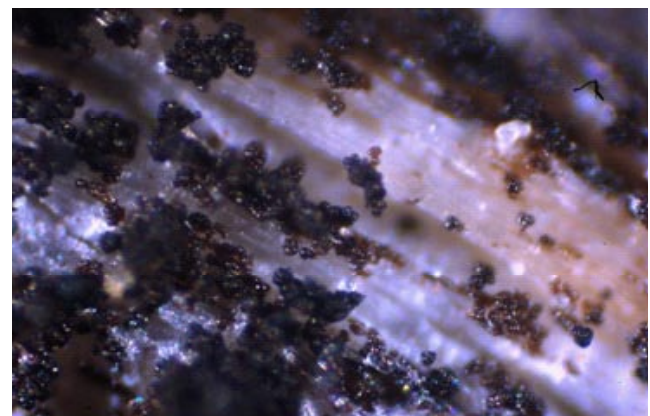
The discoloration referred to as ‘mould’ growth was found to be caused by a melanized or black form of yeast fungus from the genera *Aureobasidium* or *Hormonema*, which produces a characteristic black discoloration on new and weathered wood (*Figure 2*).

Figure 2 Melanized surface yeast growing on oak

The fungal organism uses naturally occurring sugars present in the wood, as well as the breakdown products of delignification, and requires moisture in order to sustain growth. This type of discoloration is most prevalent on unprotected aspects which are subjected to high levels of solar radiation. It is much less of a problem on areas which are sheltered from direct sunlight and rainfall, such as beneath eaves, overhangs and canopies (Figure 3).

Given that the *Aureobasidium* existed as a surface growth, attempts were also made to remove the discoloration by pressure-washing with water. This proved to be an extremely effective, quick and easy method of removal of the surface growth and enabled large tracts of cladding to be cleaned with a single pass of the water jet (*Figure 8*).

Pressure-washing was found to remove most forms of surface disfigurement easily and quickly and could be used effectively on large buildings. Using a short stand-off distance between the water lance and substrate could effectively remove the degraded surface zone of the weathered wood, restoring the cladding to its original, natural colour. Larger stand-off distances

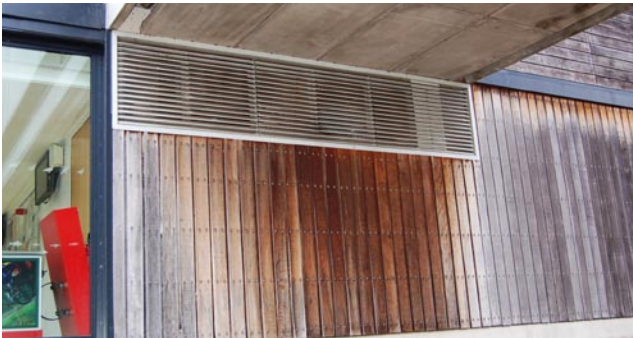
Figure 3 Typical shadow lines on cladding caused by differential weathering

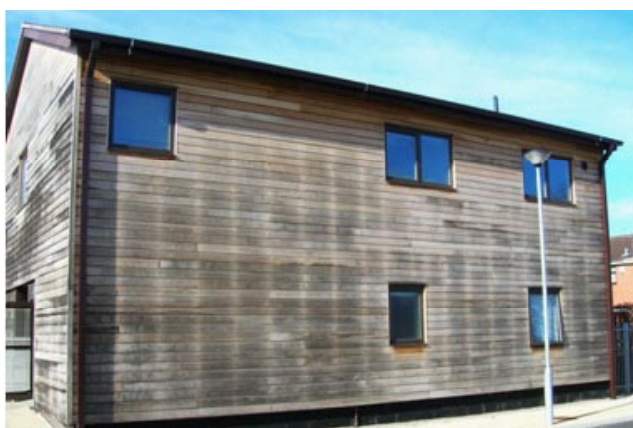
The manner in which cladding is fixed can also influence the development of this type of disfigurement. Discoloration by surface yeasts can cause the development of ‘shadow lines’, which often can be seen running down areas of cladding and which can mimic or shadow the presence of fixing battens, particularly if the inner wall of the building is not provided with an adequate vapour barrier. This can occur on close-jointed cladding, where warm air from the interior of the building can migrate into the back of the cladding, condense and prompt fungal disfigurement on the cladding surface (Figure 4).

Figure 4 Light vertical lines on close-jointed oak cladding

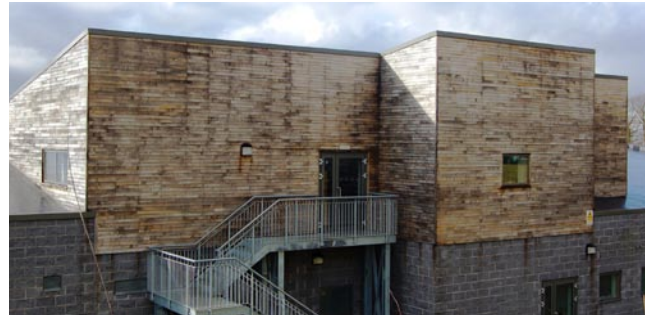
In cases where the cladding is open-jointed, rainwater penetrating past the rainscreen can be channelled down the fixing battens and held against the backs of the boards to create localized discoloration along lines of battens as vertical dark bands (Figure 5).

Figure 5 Dark vertical lines on open-jointed sweet chestnut cladding

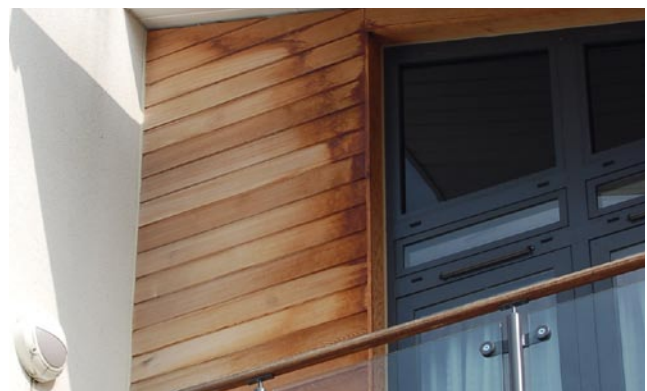
It is especially important to consider the water-shedding dynamics of buildings at the design stage, particularly if unusual designs are proposed, since the manner in which water is shed down the building may be a factor in determining whether this form of staining is likely to develop. The research indicated that this form of staining occurs as a tenuous surface phenomenon which, in severe cases, can form a discrete zone of extractives at the surface (Figures 6 and 7).

Figure 6 Extractive staining on western red cedar beneath break in eaves canopy

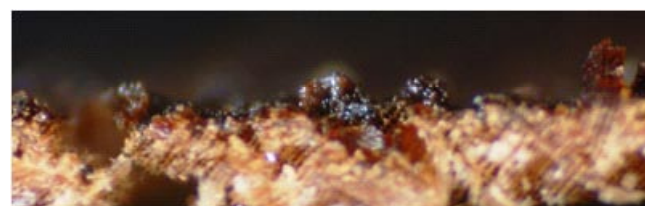
Figure 7 Transverse section taken from surface of western red cedar cladding with severe extractive staining, showing dark-coloured extractives confined to the surface zone

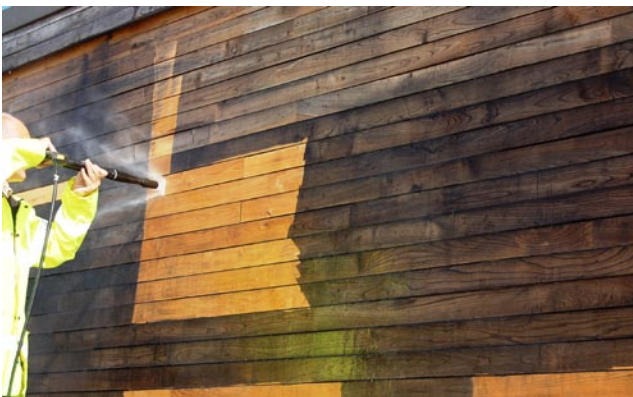
Figure 8 Surface cleaning of discoloured sweet chestnut cladding using a domestic pressure washer

The process of pressure-washing also removed the friable zone of delignified surface fibres on the wood caused by the process of weathering, restoring the original colour of the wood. In addition, it was effective against disfigurement caused by tannin redistribution. This meant that the same process could be used to remove three of the four principal causes of discoloration identified by the literature review as being the most problematic to consumers, (i.e. bleaching/surface greying, tannin staining and mould discoloration).

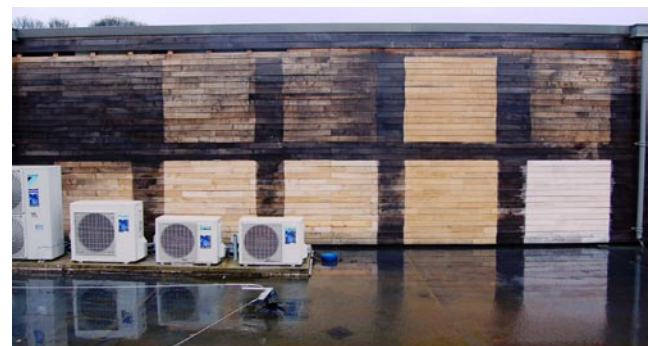
Some test areas were left in their cleaned condition with no treatment, in order to investigate whether any residual uptake of the cleaning products used (bleach, sodium hydroxide, etc) conferred any long-term protection against the re-colonization of the surface micro-organisms (*Figures 9 and 10*).

Figure 9 Test areas on sweet chestnut 14 months after cleaning, showing differential levels of re-colonization according to treatment

Significant re-colonization by surface yeasts and subsequent disfigurement was found to recur within one year of cleaning by pressure-washing alone. Washing with caustic soda and hypochlorite-based bleaching products slowed the re-emergence of surface discoloration to some extent, but moderate levels of discoloration still re-emerged within one year.

While treatment with a brush-applied preservative prevented re-colonization by surface yeasts, substrate bleaching was found to be significant after one year. Treatment of the surface with a resin-based decking-protection product yielded the best results in terms of preventing the re-emergence of surface discoloration after approximately one year of weathering, and also minimized or prevented subsequent bleaching of the substrate over that time.

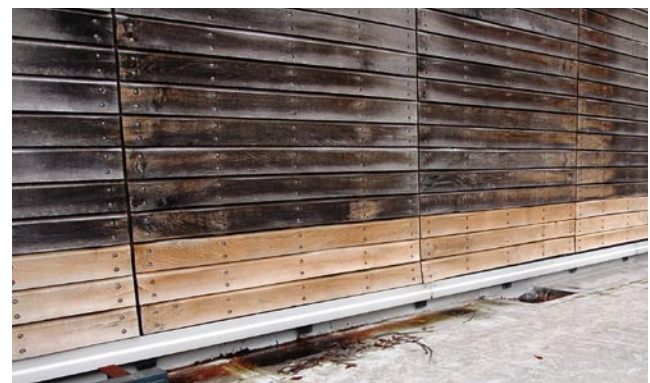
Figure 10 Test bays on oak cladding immediately following cleaning and treatment

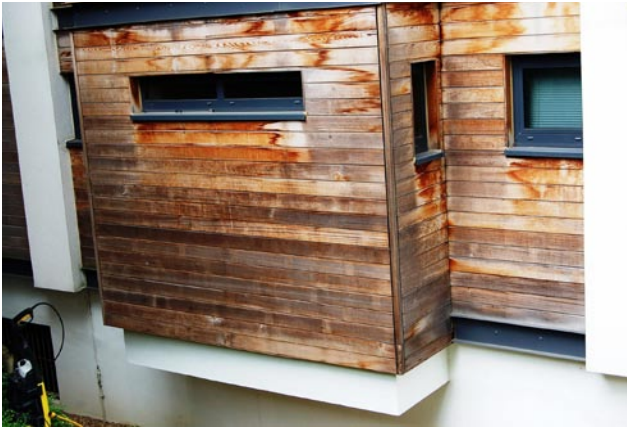
Figure 11 Discoloured western red cedar cladding before cleaning and treatment

Pressure-washing was found to be the most effective method of cleaning discoloured cladding. In one field case study, the opportunity arose to demonstrate the process to good effect on a three-storey building project. The facade was clad with horizontal close-jointed western red cedar boards, pressure-washed and then treated with a colourless, resin-based decking-protection product as an expedient to prevent the re-emergence of discoloration and extractive staining (compare *Figures 11 and 12*).

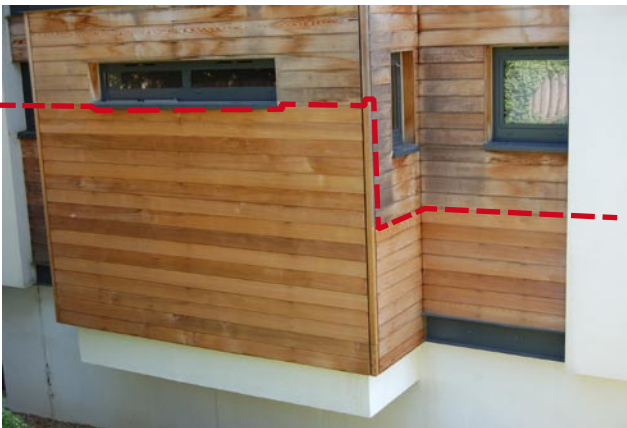
Figure 12 Discoloured western red cedar cladding following cleaning and re-treatment
